Calculating Corrosion

**A cost-effective approach to evaluating
hydrogen sulfide deterioration
in a concrete interceptor**

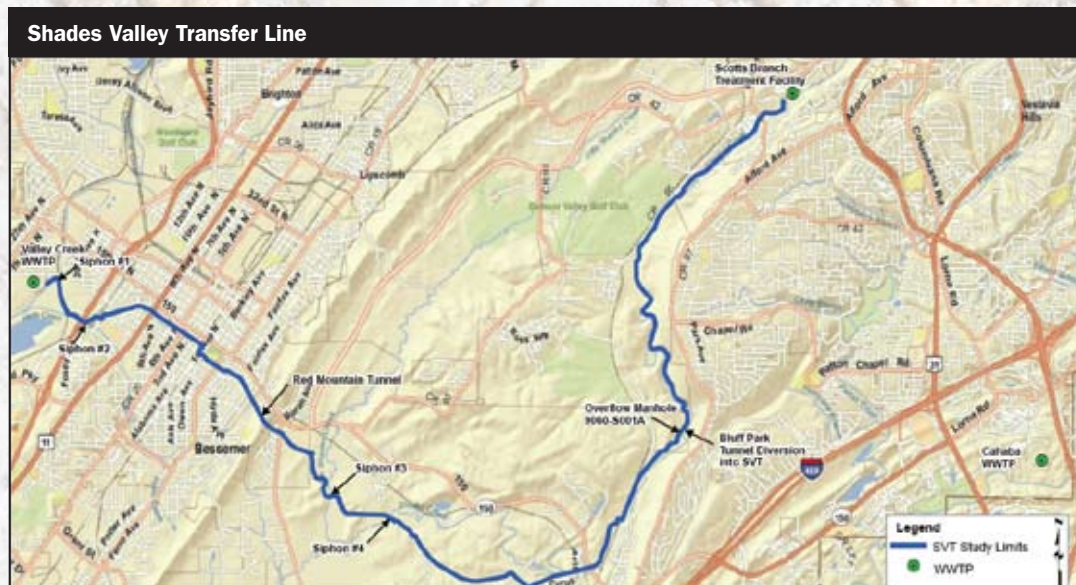
The SVT, which varies from 4.5 ft (1.4 m) to 6.0 ft (1.8 m) in diameter, was constructed in 1986 to abandon the Shades Valley Wastewater Treatment Facility by pumping wastewater

to the Valley Creek Wastewater Treatment Plant (see figure below). Shortly after construction, ESD became aware of significant levels of hydrogen sulfide corrosion that likely were due to high-strength industrial wastewater and pump-station force mains discharging into the line.

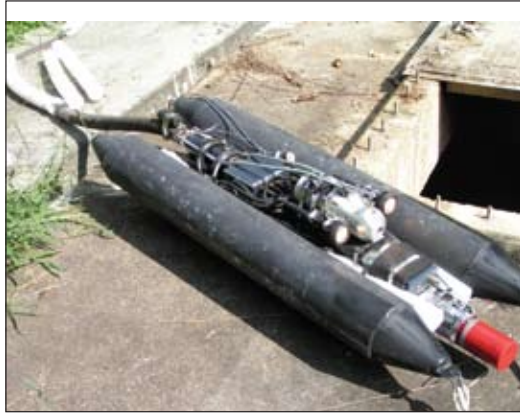
The inspection contractor used a floating transport with closed-circuit television and sonar sensor technologies to inspect about 21,000 ft (6400 m) of the Shades Valley Transfer line. Track-mounted inspection equipment couldn't fit through the line's access structures.

Access limitations were largely due to the type of access structure constructed with the SVT. The access structures contained only a 30-in. (762-mm) opening at the entrance to the pipe. This did not provide sufficient clearance for the insertion of a tracked inspection vehicle. As a result, only a floating transport with closed-circuit television and sonar sensor technologies was feasible for the inspections. Due to the cost savings provided by the elimination of ground-penetrating radar, the extent of the inspections was increased to 23% of the system.

The inspection contractor used a float and sensor assembly to inspect approximately 21,000 ft (6400 m) of the SVT.
